STURMPANZER SPOTTERS GUIDE

[Stu.Pz.Kp. z.b.V. 218]

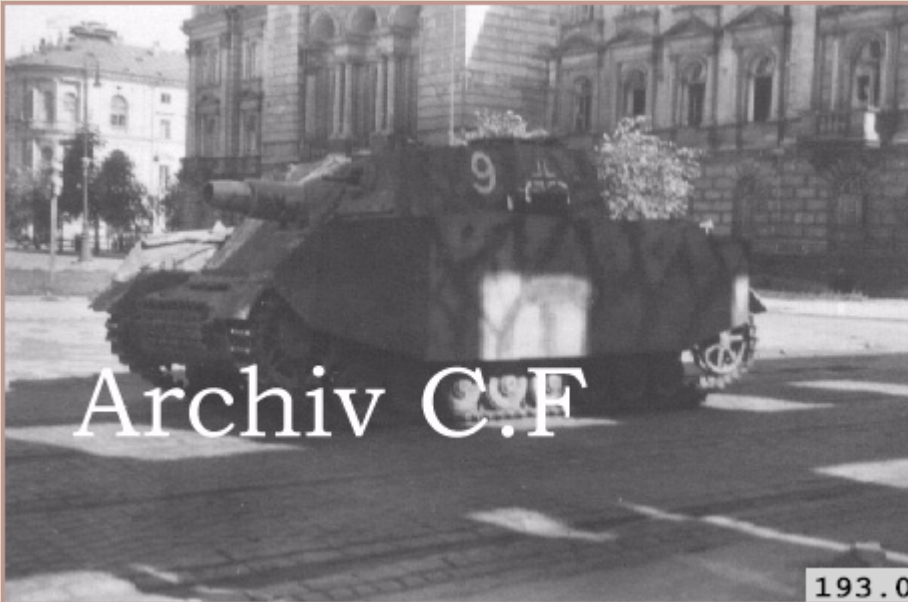
Figure 1.

Sturmpanzer near Marshall Pilsudski's Square.

This is a great photo that clearly shows the large tactical number in white along with the balken cruz. You can also clearly see the camouflage pattern on the side skirts. Close inspection also reveals all steel wheels.

This photo was possibly taken soon after arrival as all the side skirts are still in place.

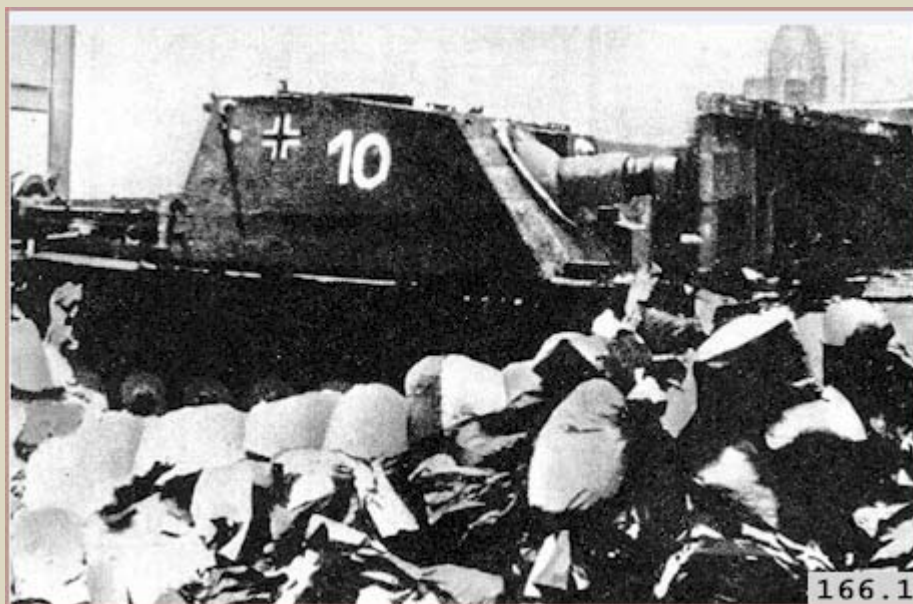
Figure 3.

Sturmpanzer in during the Warsaw uprising. You will notice the large tactical number 10 and steel wheels on the visible wheels. The zimmerit is not noticeable but it is obviously a series 4 model.

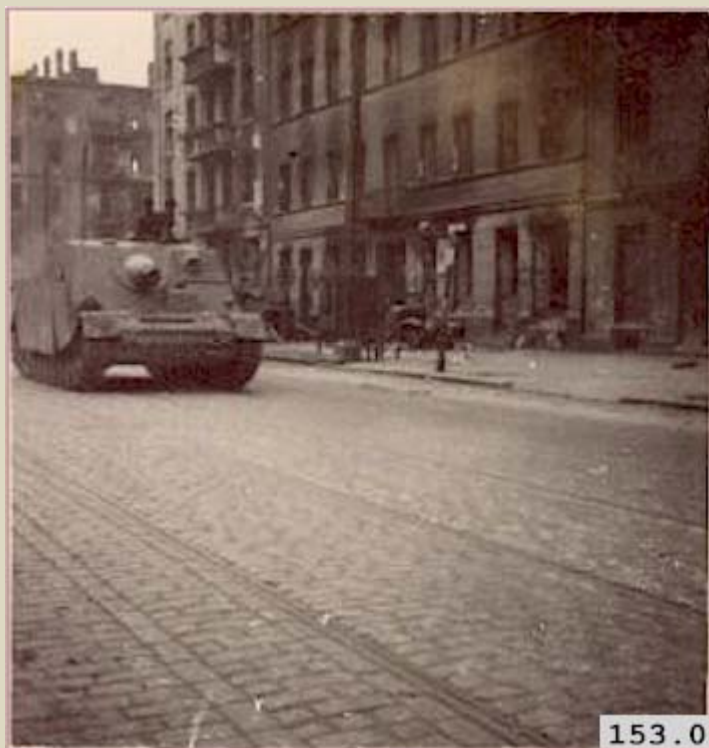
Figure 4.

Sturmpanzer in the streets of Warsaw. Not much can be made out from this photo other than it is a series 4.

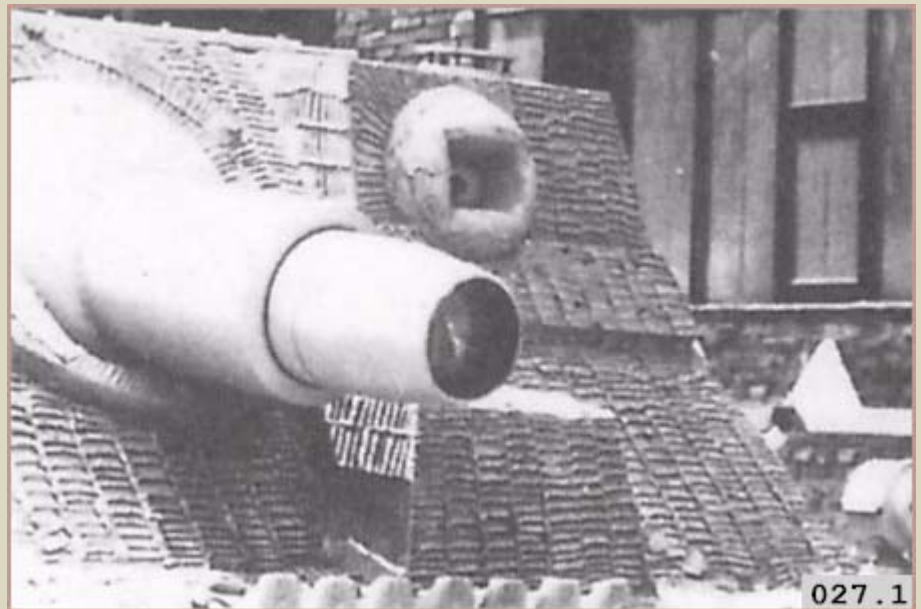
Figure 10.

Sturmpanzer with course Zimmerit.
